RENAULT

7 Trim and upholstery

X84, and B84 or C84 or G84 or S84

Mégane II - Section 7

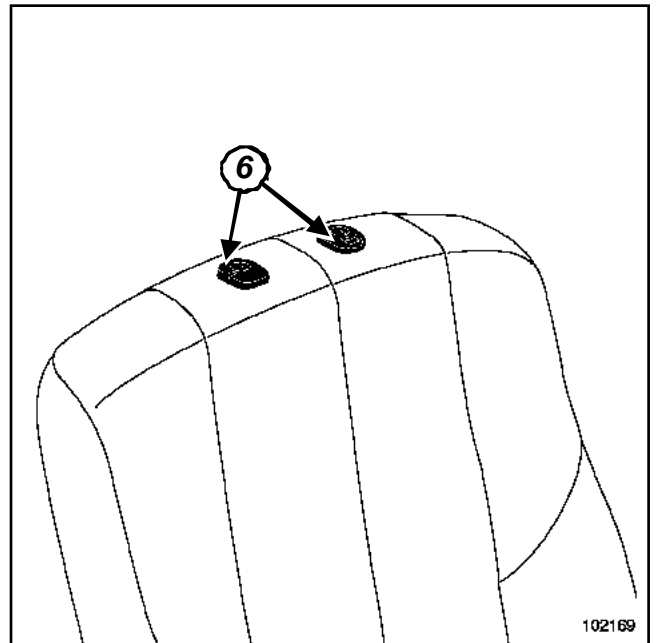
- remove headrest guide covers (6).

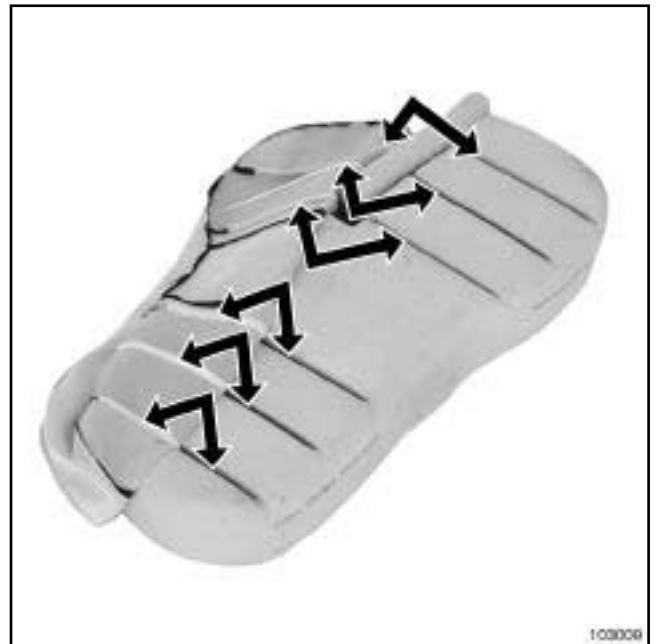
103009
103009

- Remove the Velcro strips.

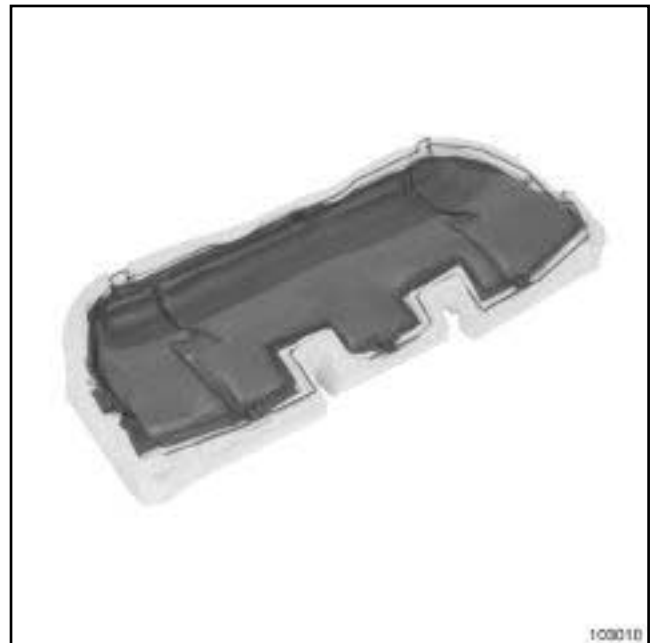
103010
103010

- Remove the frame.
